The Saga of Rebuilding a Rotoflex Triumph Vitesse Independent Rear Suspension

David Brooks – 28th July 2022

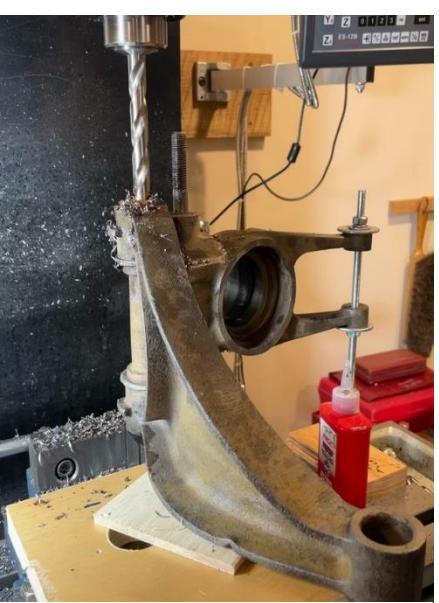
Photo 3 - Drilling out bolt

The bottom wishbone is bolted to the hub axle with a $\frac{1}{2}$ inch diameter $7\frac{1}{2}$ -inch long bolt which was rusted solid inside the hub. After much banging and heating etc, the only solution to was to drill out the bolt, much easier said than done due to its length.

A 3/8inch hole was therefore drilled into the bolt to a depth of $2\frac{3}{4}$ inches and a stock 3/8 steel rod tapped in. This rod was then placed into the V-blocks on the mill and using the hat guide on the this end of the bolt, the drilling could start. The drill size was increased in stages from 3/8 to 31/64 inches (Photo 3). The assembly was then turned over and re-aligned on the shock absorber bolt. The same drilling operation was used with plenty of Tap Magic whilst watching the rust and swarf emerging from the hole. The depth was controlled so that a small piece of the bolt

remained close to the center of the hub. Note that a piece of wood was used to support both the wishbone and the threaded rod placed through the hub axle spring mounting holes. This reduces any vibration while drilling and also protects the mill bed and vice. The wishbone was then removed and the "plug" of bolt in the center of the hub axle hammered out using a metal punch, the remains of the bolt largely disintegrated and the hole was cleaned out by hand using a ½ inch drill. Success!

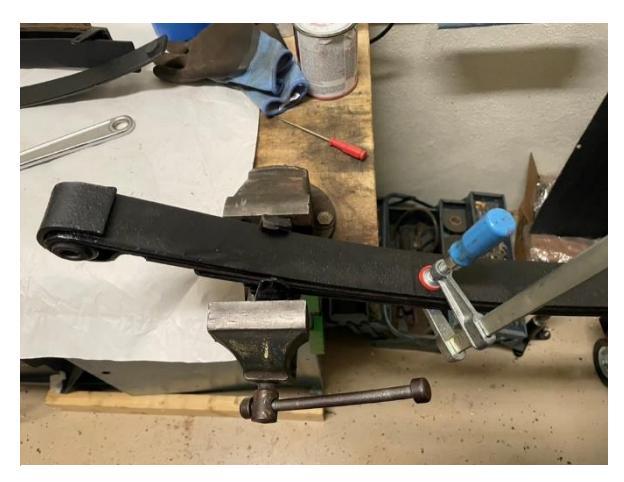
Photo 7 - Closing the outer spring clamps

ends of the longest leaves on all transverse spring cars, allegedly to ensure silent operation but over the years these get squished flat which lowers the rear of the car. Fortunately, these buttons along with the bushes that mount the spring to the axle hubs are still available (Photo 7 - after rebuild). The spring center bolt is not, but as these were made of mild steel, one was fabricated on the lathe.

Rebuilding the spring required the use of a vice to bend back the outer clamps while holding the spring together, in my case using woodworking clamps, I glued the buttons in place to prevent them falling out during this procedure.

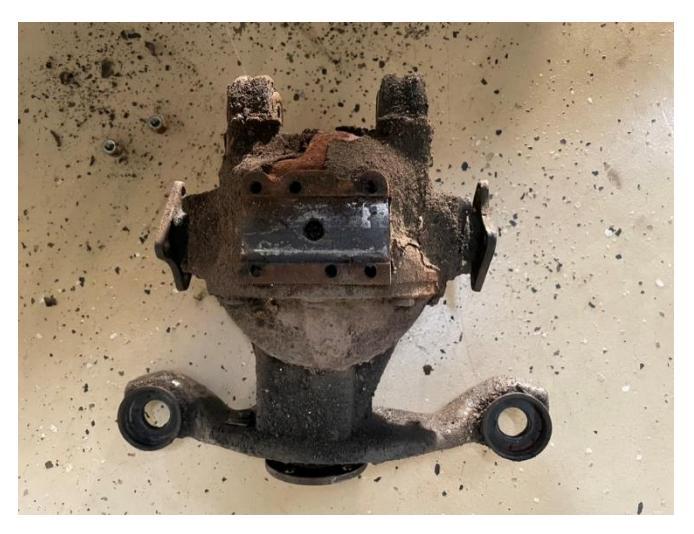
Photo 9 - Differential as removed

The top of the differential was nasty (Photo 9) covered in about ¹/₄ inch of pure 1990s English mud and dirt, a large screwdriver was used to get rid of the worst of it and the pressure washer did the rest. The half-shafts were then removed from the differential by unscrewing the four Allen bolts and gently levering out the shafts. A bearing puller was used to take the bearings and leaking
