Know Yer Trunnions?¹

One of the mysteries of the small-chassis Triumphs (Spitfire, Herald, GT6, Sports 6 & Vitesse) is the use of “Trunnions” in the front suspension rather than the kingpins used in other British

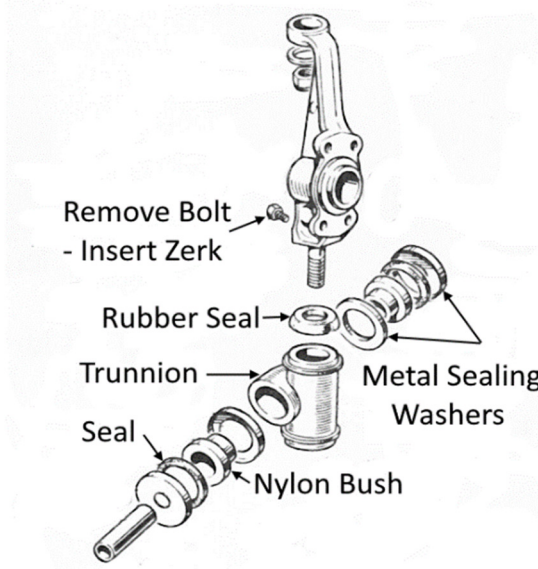
Figure 1 - Trunnion and Vertical Link

vehicles of a similar era. Trunnions are made of brass, are lubricated with hypoid oil rather than grease, and can be adjusted for wear (up to a point).

Although the trunnions and the vertical link look almost the same for both sides, this is not the case - the LHS of the car has left-handed threads on the trunnion and link whereas the RHS has right-handed ones.

The mounting of the trunnions to the lower wishbone is through a nylon bush with a steel insert. Water ingress is prevented by the use of a rubber seal which is held in place by 2 sealing washers at each end.

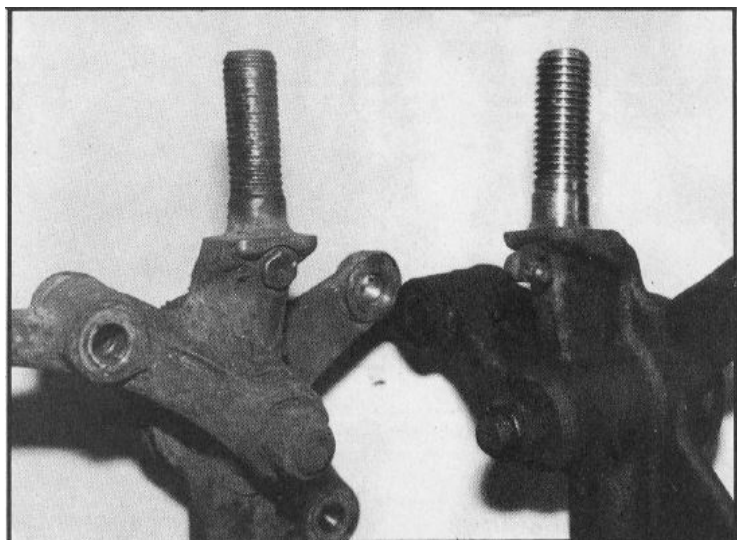
Figure 2 - Poor v. Well Maintained Trunnion

If your trunnion maintenance has been neglected for an extended period, Figure 2 shows what can happen. Note LHS has the original plug bolt and RHS has a zerk.

In extremis, the trunnion and vertical link can part company while driving, fortunately maximum force on this component happens on full steering lock at low speeds.

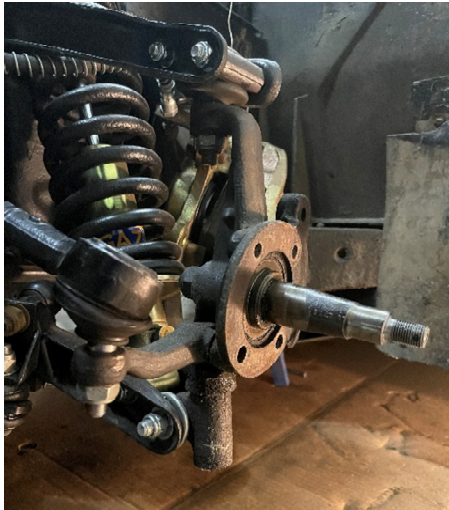
Figure 3 - Rotor & Backplate removed

The first step is to take off the front rotor caliper. Rather than removing the brake pipe, I prefer to hang the caliper up using an old wire coat-hanger, in this case over the battery retaining bolts. This ensures no stress is placed on the flexible brake line and obviates the need to bleed the brakes afterwards.

The stub axle nut can then be wound out and the rotor and hub assembly removed from the car.

This reveals 4 bolts which hold the back plate onto the vertical link. The bottom 2 bolts also connect to the steering arm which is attached to the rack ball joint.

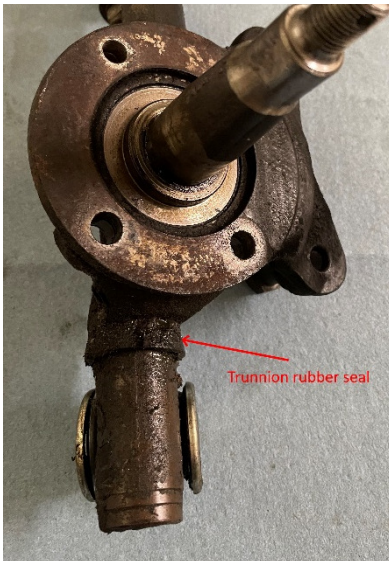
Figure 4 - Vertical Link & Trunnion as removed

Once off the car, the trunnion can now be wound off the upright and both parts examined for undue wear.

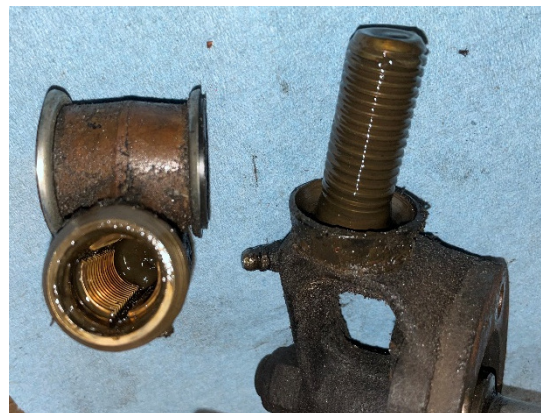
Figure 5 - Dirty but OK?

The parts were put into an ultrasonic cleaner, but a kerosene bath would have worked just as well.

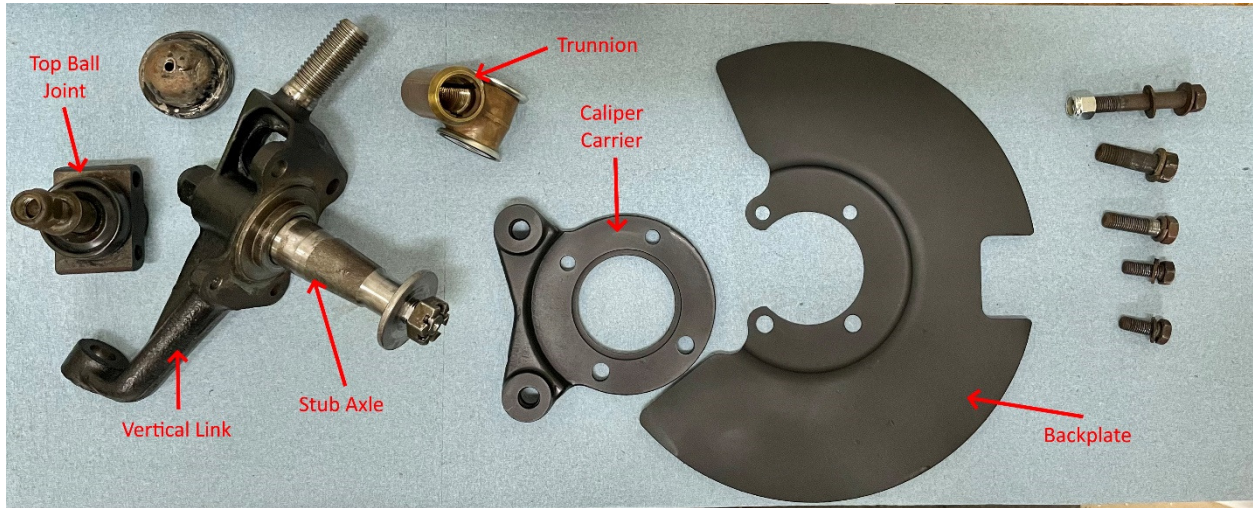
Figure 6 - All parts cleaned & painted ready for reassembly

Once all the parts were cleaned and the steel parts sandblasted and repainted, reassembly can begin. In my case, no new parts were needed apart from the various seals.

Note that the caliper carrier has been removed from the vertical link. It is held on to the vertical link by the same 4 bolts that hold the backplate in place.

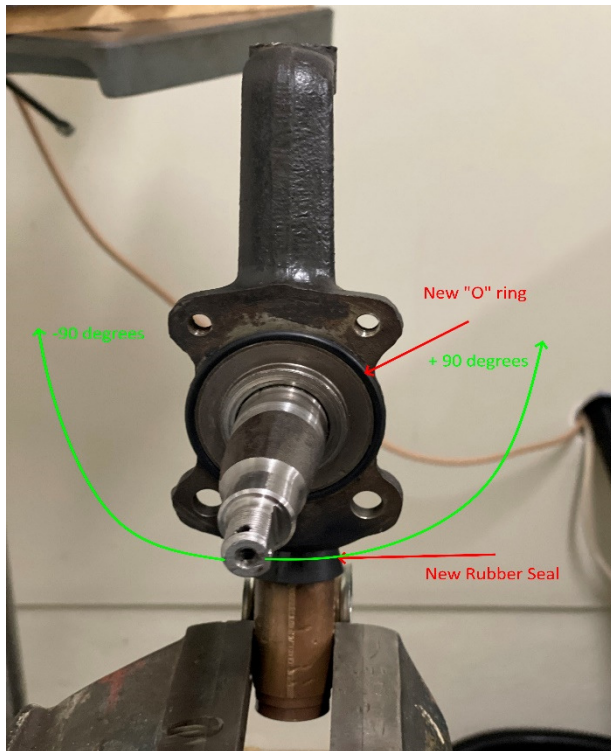
Figure 7 - Assembly of Vertical Link & Trunnion

Remove the bolt or zerk from the vertical link and fill the trunnion 1/3 full with Hypoid 90 or similar oil. Put a new rubber seal at the end of the threaded portion of the vertical link and screw in the trunnion. Oil should come out of the zerk hole. Screw in the vertical link as far as possible, but ensure that the stub axle can rotate freely through +/- 90 degrees from the center position (as on the car) and shown in Figure 7, if tight loosen the trunnion by one turn.

Screw the zerk into the back of the vertical link.

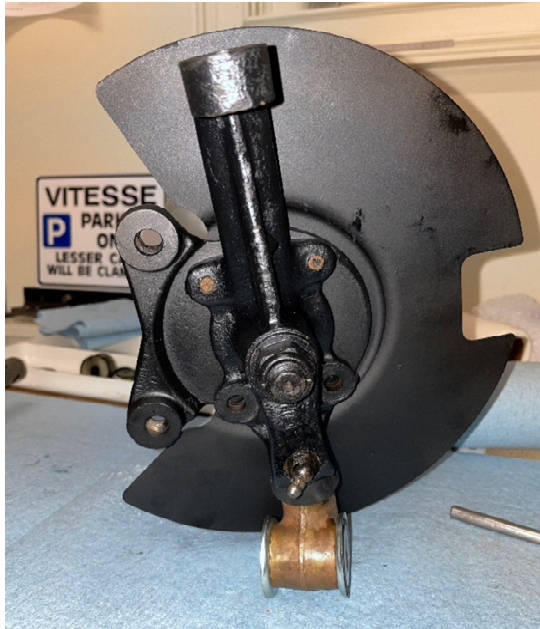
Figure 8 – Assembled vertical link

The caliper carrier and the backplate can now be assembled onto the vertical link as shown in Figure 8 using only the top 2 smaller bolts – do not tighten fully.

Note that once the backplate is in place, the trunnion can no longer be adjusted.

There is an "O" ring between the vertical link and caliper carrier which prevents water ingress into the axle bearings. This should be replaced – an R-32 "O" ring works nicely.

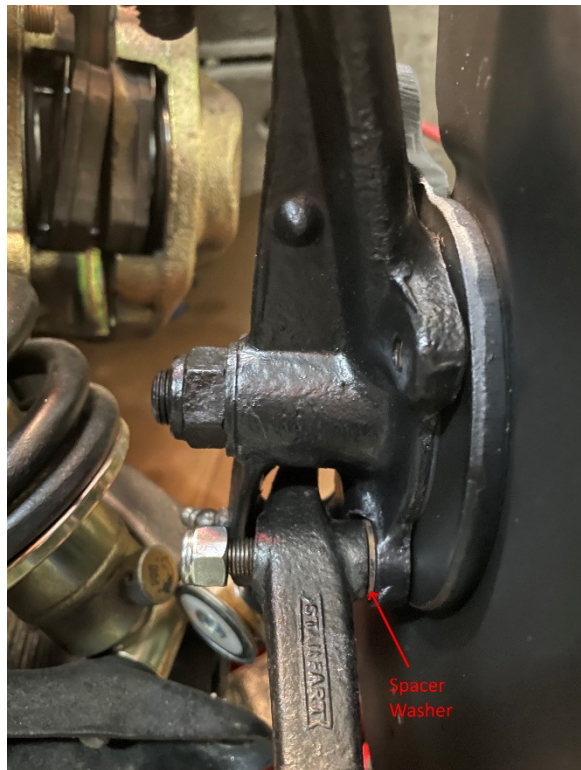
Figure 9 - inserting the Steering Arm

trunnion is bolted to the bottom wishbone. Note that oil or grease should not come into contact with the nylon bushes in the trunnion as this will cause them to expand and wear prematurely.

The steering arm is inserted through the vertical link. Don't forget the spacer washer between the front facing attachment point and the vertical link as shown in Figure 9. This must be done before the
