The Saga of Rebuilding a Rotoflex Triumph Vitesse Independent Rear Suspension

David Brooks – 28th July 2022

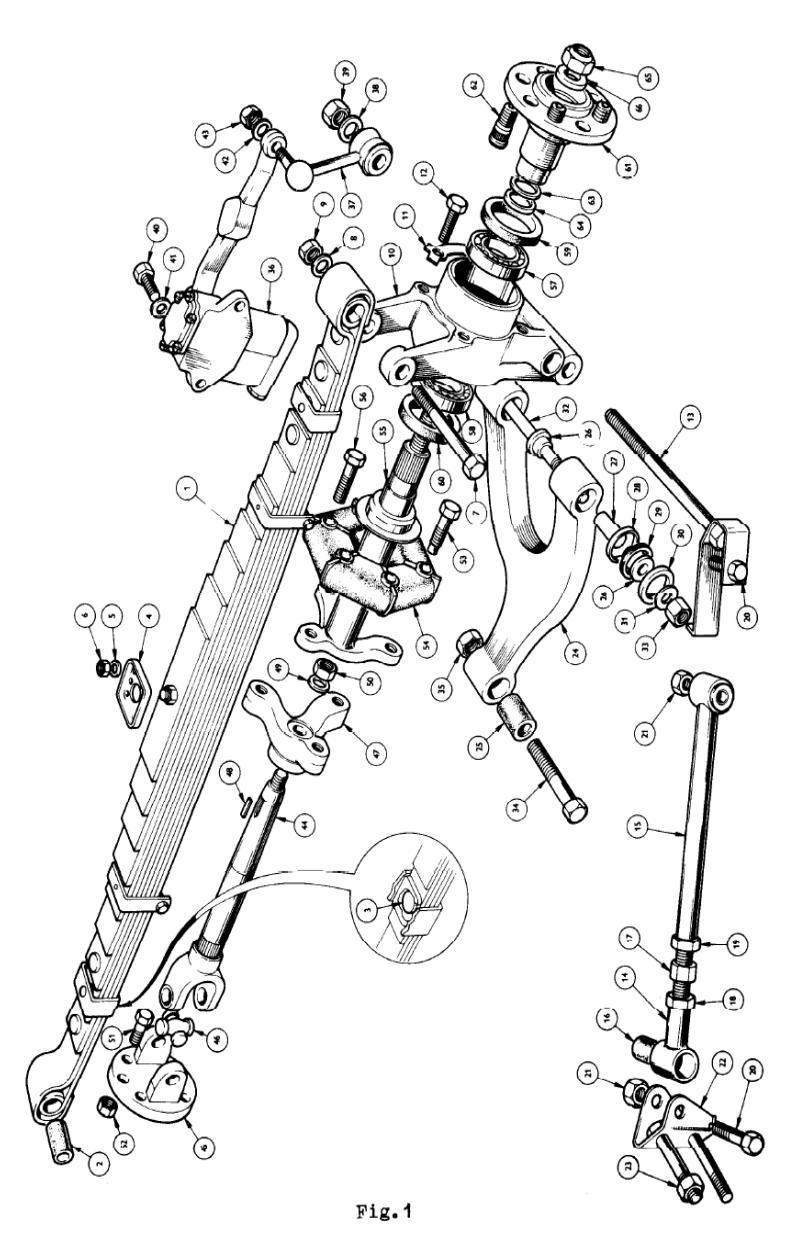
Figure 1 - British Leyland Dealer Training Manual for GT6+ #SST1

center of the bolt? As the bolt was rusted solid to the steel spacer upon which the wishbone nylon bushes rotate, (Figure 1) both ends of the bolt were cut off and filed to be flush with the spacer – the remains of the bolt being around 6 inches long. After prizing out the outer half of each nylon bush, a
